Hanford Advisory Board River and Plateau Committee

Plutonium Finishing Plant (PFP) Closure Project

Overview and Project Status

April 2016

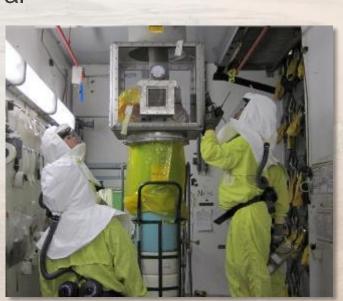
Plutonium Reclamation Facility 236-Z

- All pencil tanks removed
- Work underway:
 - Canyon decontamination
 - Gallery glove box preparation
 - Process and chemical line removal

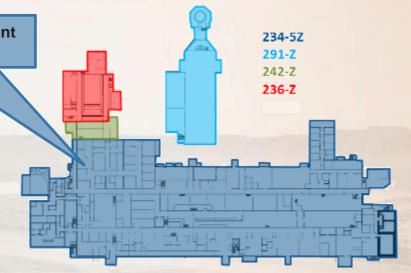
Plutonium Finishing Plant 234-5Z

- All glove boxes/hoods taken off ventilation
- In-situ glove box size reduction complete
- Work underway:
 - Ventilation duct removal

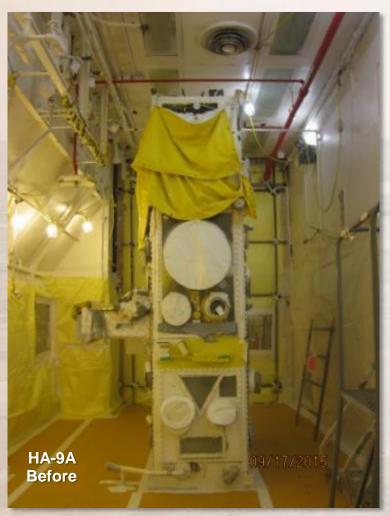
PFP: In-Situ Glove Box Size Reduction

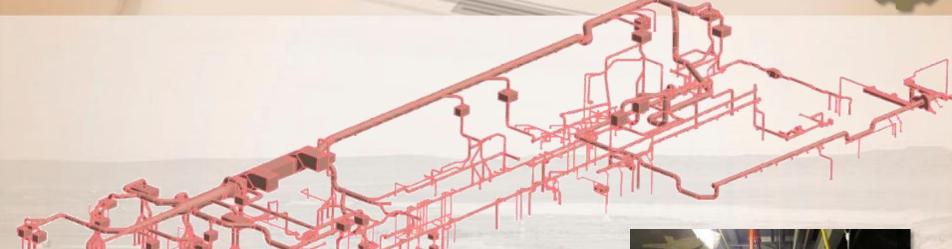
PFP: Ventilation Duct Progress: 2014

8,882 total feet of E4 ventilation duct to remove/prepare for removal

Employees modifying the ventilation system to support duct removal

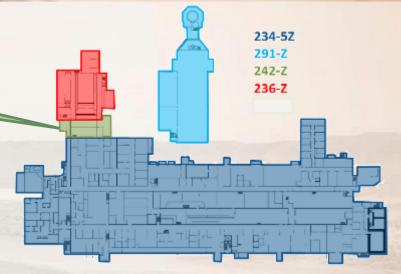
"McCluskey Room"
242-Z
Americium Recovery Facility

- Three remaining glove boxes removed
- Work underway:
 - Preparing to remove chemical tanks during demolition

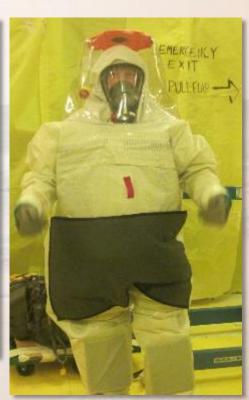
Release Limits <20 DPM/100 cm² Removable Contamination

20 DPM/100 cm² .2 DAC

2,000 DPM/100 cm² .2 DAC

25 million DPM/cm² 206,000 DAC

Increased contamination levels and safety equipment required

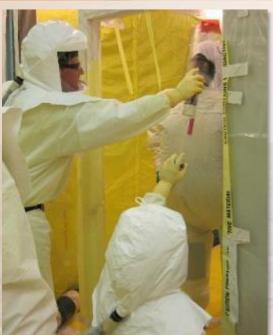
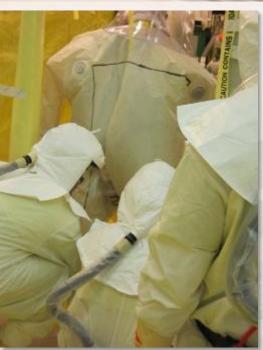
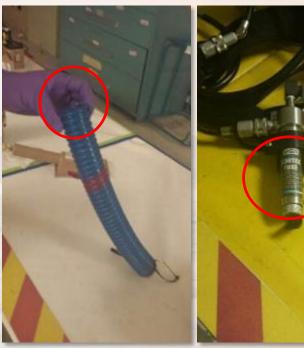
CHPRC improved the process of doffing/removing Level B PremAire suits after several skin and clothing contaminations, including the use of additional fixative outside of the suit and additional protective clothing under the suit.

Red circles on the exhaust hose (left) and vortex cooler (right) indicate where contamination was discovered. Following discovery, CHPRC strengthened release processes.

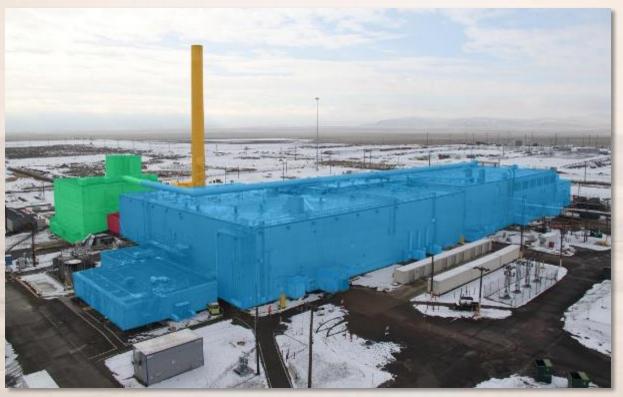
PFP Timeline and Sequence

I	Demolition Sequence and Duration					
ı	236-Z Plutonium Reclamation Facility	10 weeks	3	234-5Z Plutonium Finishing Plant	17 weeks	
	2 242-Z Americium Recovery Facility	2 weeks	4	291-Z Ventilation Stack and Fan House	9 weeks
